Manhole Inspection Summary

Manhole # S09GG1005MH

Insp Date: **2/8/08 4:11 PM**

Location Address: **3636 DOLFIELD RD** Cross Street: **RIDGEWOOD AVE**

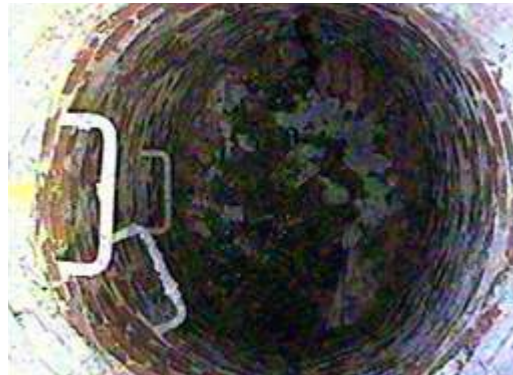
Top View

Cover Shape: **Circular** Diameter: **25.** (in.) Length: (in.) Dist A/B Grade: **0** (in.)
75

Type: **Sanitary** Condition: **Sound** Cover Material: **Cast Iron**

Frame Offset: **0** (in.) Condition: ☒ Sound ☐ Cracked ☐ Leaks

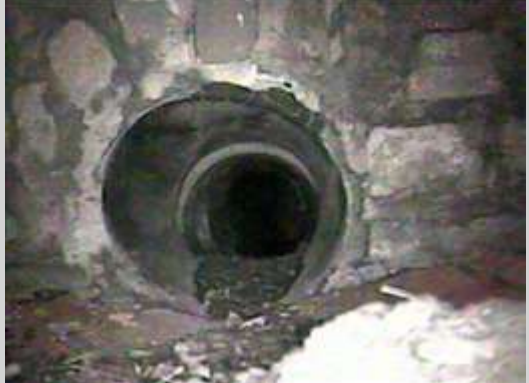
12 O'Clock Outflow

8 in. Circular Gravity Sewer
Pipe Out @ 12 O'Clock

Pipe Material: **Clay** ☐ Pipe Lined

Deposits: ☐ None ☒ **Mud** ☐ Sludge ☐ Debris ☐ Grease

Silt Depth: **0** (in.) Deposits Extent: **Light**

Infiltration: **None** Pipe Seal Cond: **Sound**
